Case Studies

Case Numbers | 102, 105, 111, 113, 121, AJ-GW 1, AOP-GW1, AOP-GW2, AOP-GW3, AOP-GW4, 1187034

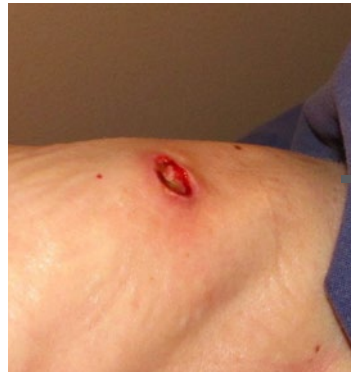
Decubitus ulcer, stage III caused by orthotic corrective pad at right thorax.

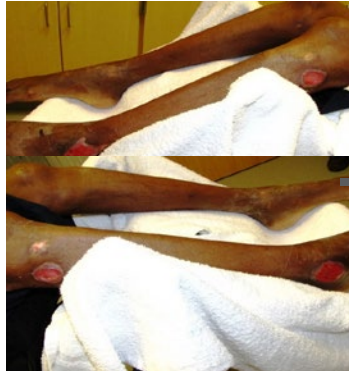
Multitude of decubitus ulcers stage III at the lower extremities caused by night time bed positioning.

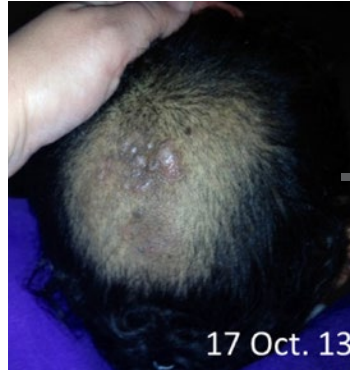
Inflammation, callus and blistering formation on back of head. Severe hair loss.

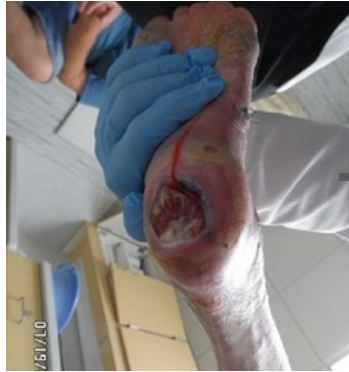
Decubitus ulcer, left heel, stage II.

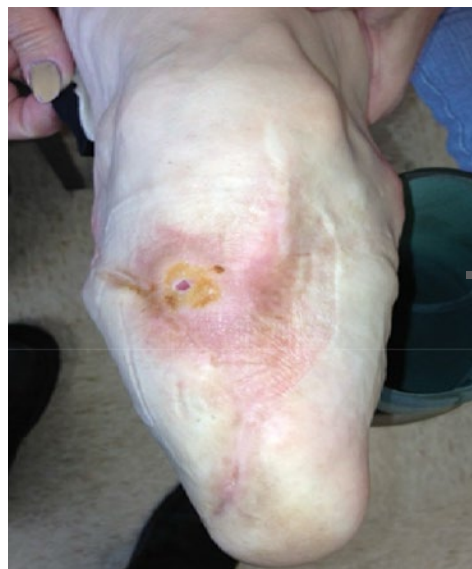
Scan to learn more about
GlideWear® from Tamarack®

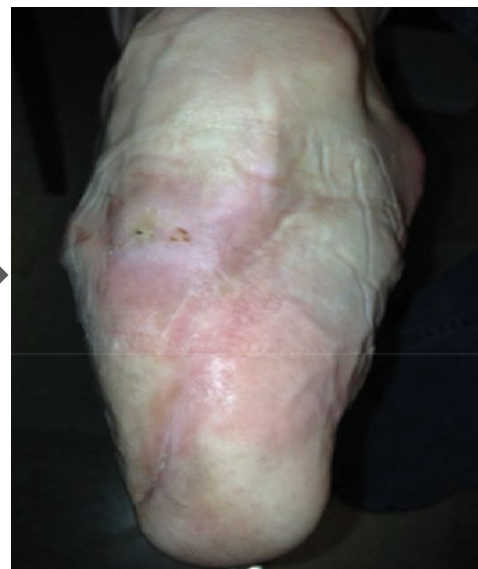
Wearing GlideWear patch full time.

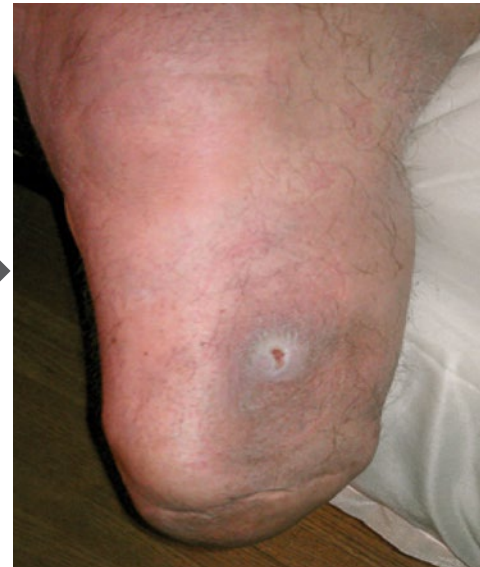
Patient is placed in a casting liner with GlideWear patches to start daily use of patches. Replacement liner is ordered.

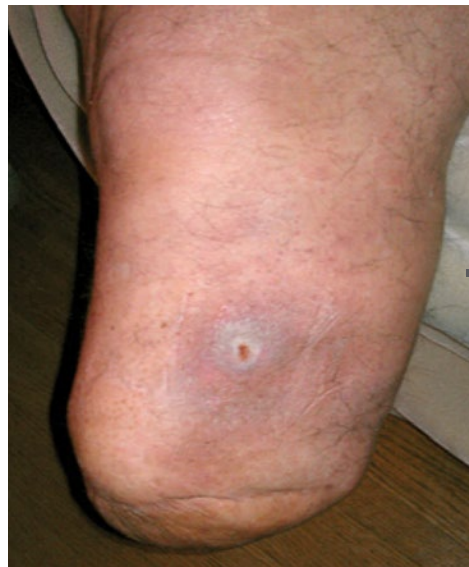
GlideWear patch is being worn full time.

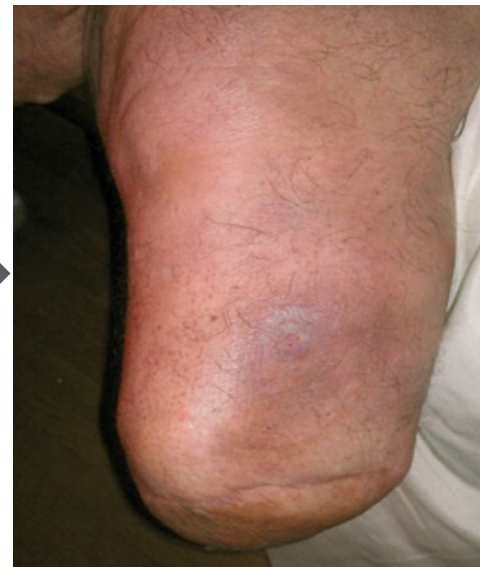
GlideWear patches being worn full time.

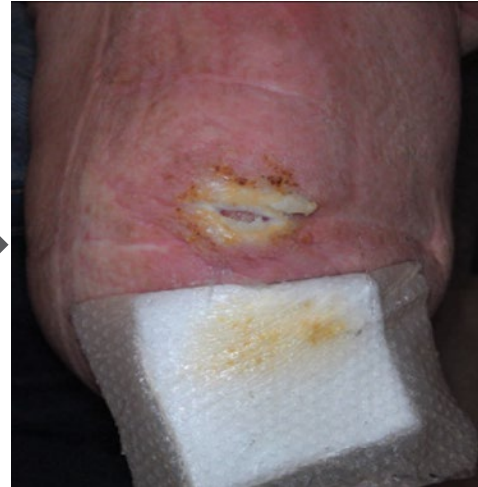
Pads are placed in anterior socket and proper sock ply is established with patient. GlideWear patches are placed in gel in for full time use. Patient is retired, but still is active around his home.

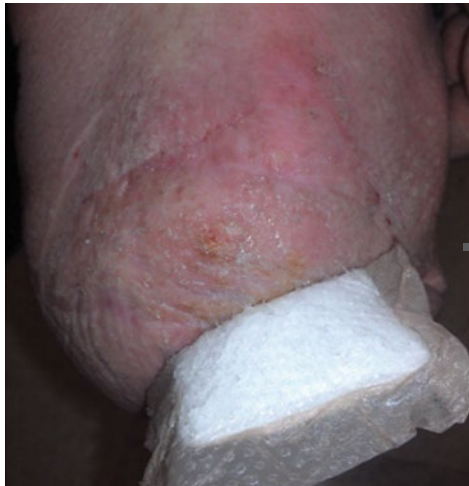
Patient is using GlideWear patch full time in prosthesis.

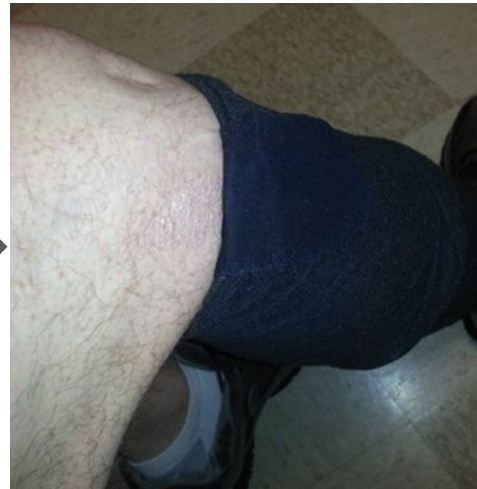
GlideWear patch worn full time.

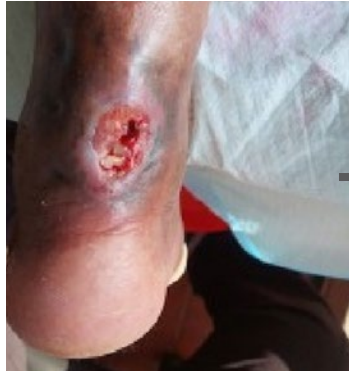
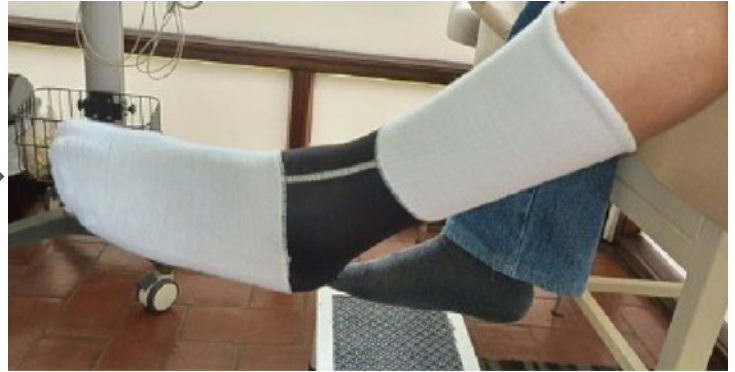
Condition
Decubitus ulcer, stage III
